MEMORANDUM

| SUBJECT: | Weekly Progress Report @ Gold King |

Project: Gold King Interim Water Treatment Plant (IWTP)
Location: Gladstone, Colorado
Prepared for: Emergency Response Unit – US EPA Region 8

Reporting Period: May 2 – May 9
Report No.: 20

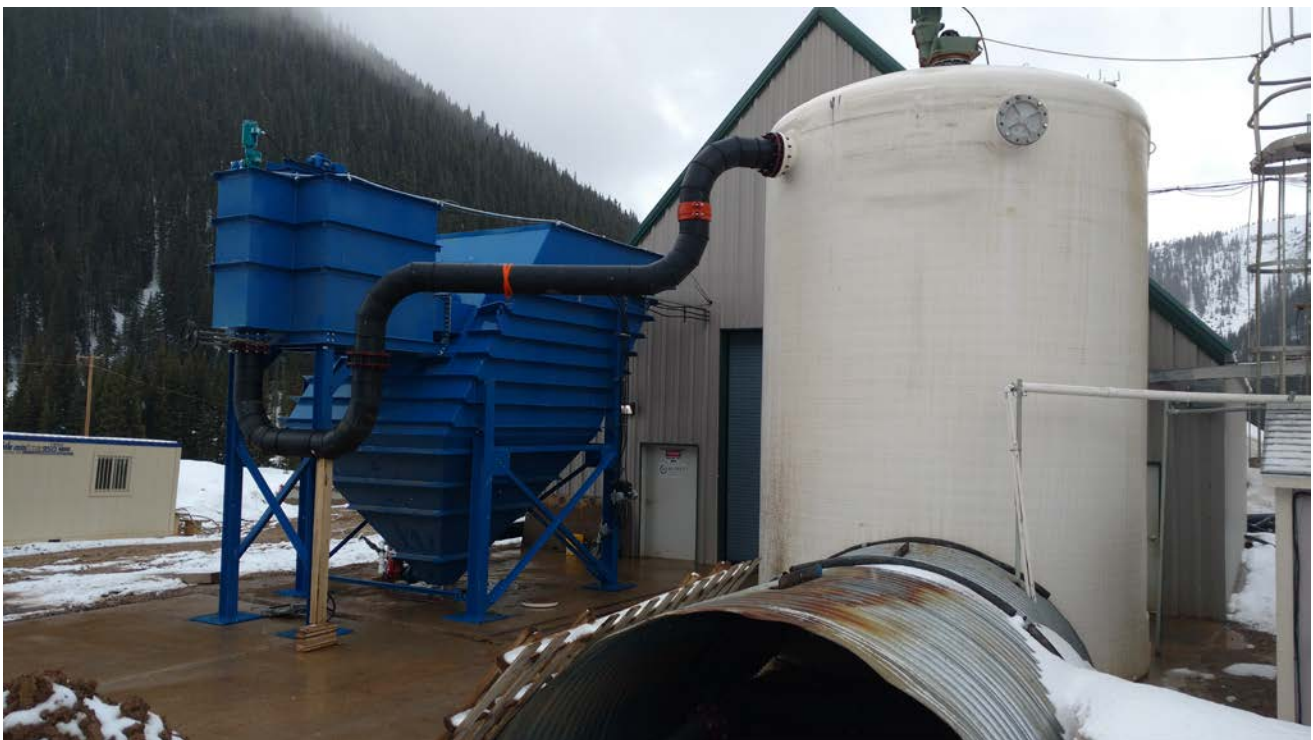
Photo 2: Completed installation of the 2nd clarifier – Taken on 4/10/2016

- **Spring Melt Contingency Updates:**
 - **Second Clarifier** – Alexco has received written notice to move forward with the installation/operation of a rental clarifier and supporting infrastructure required for spring melt. The system was tested and became operational on Sunday, May 8th.
 - **Additional Bags** – Alexco has additional textile bags (2X 125' x 45 and 1X 90' x 45') located at site that can contain an additional 2,000 CY of sludge. Alexco is able to install one or two of these additional textile bags as needed during spring melt.
